Manhole Inspection Summary

Manhole # S47G__011MH

Insp Date: **7/30/08 10:36 AM**

Location Address: **232 S Chester St**

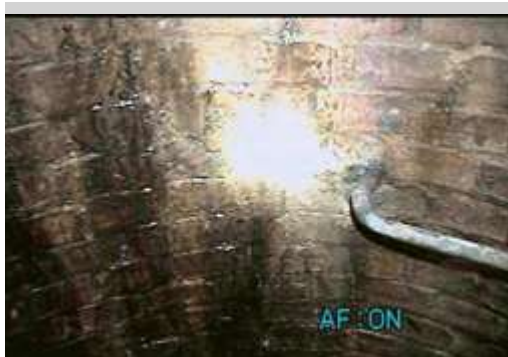
Defect 3

Infiltration: ☐ None ☒ **Joint** ☐ Cracks ☐ Mortar ☐ Roots ☒ **Wall**

barrel infiltration at wall joint

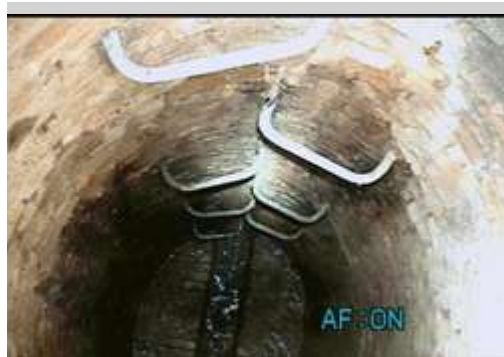
Defect 2

Steps Count: **7** Missing: **0** ☒ **Corroded**

steps

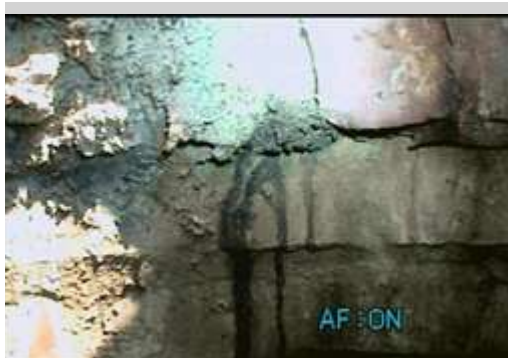
Defect 1

Condition: ☐ Sound ☐ Cracked ☐ Root Intrusion ☐ Loose Brick ☒ **Deteriorated**

chimney cond deteriorated

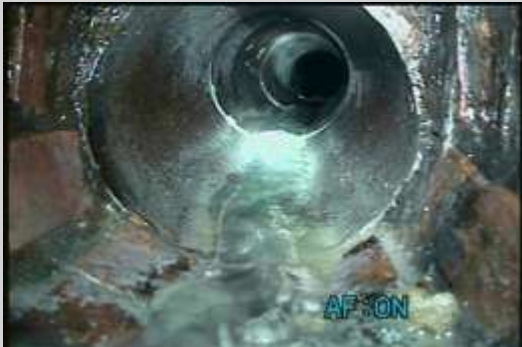
12 O'Clock Outflow

8 in. Circular Gravity Sewer
Pipe Out @ 12 O'Clock

Pipe Material: **Clay** ☐ Pipe Lined

Invert Depth: 11.81 (ft.) Flow Characteristics: **Fast**

Infiltration: **None** Pipe Seal Cond: **Unknown**

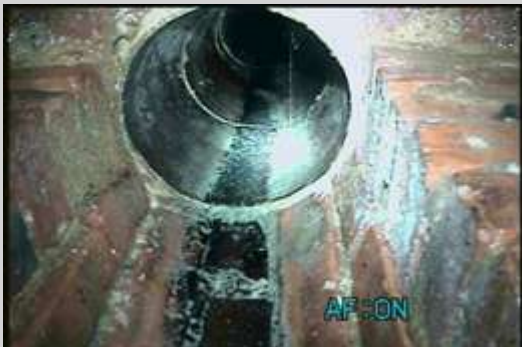
6 O'Clock Inflow

8 in. Circular Gravity Sewer
Pipe In @ 6 O'Clock

Pipe Material: **Clay** ☐ Pipe Lined

Invert Depth: 11.75 (ft.) Flow Characteristics: **Fast**

Infiltration: **None** Pipe Seal Cond: **Unknown**
